AC in PHENIX

Stefan Bathe

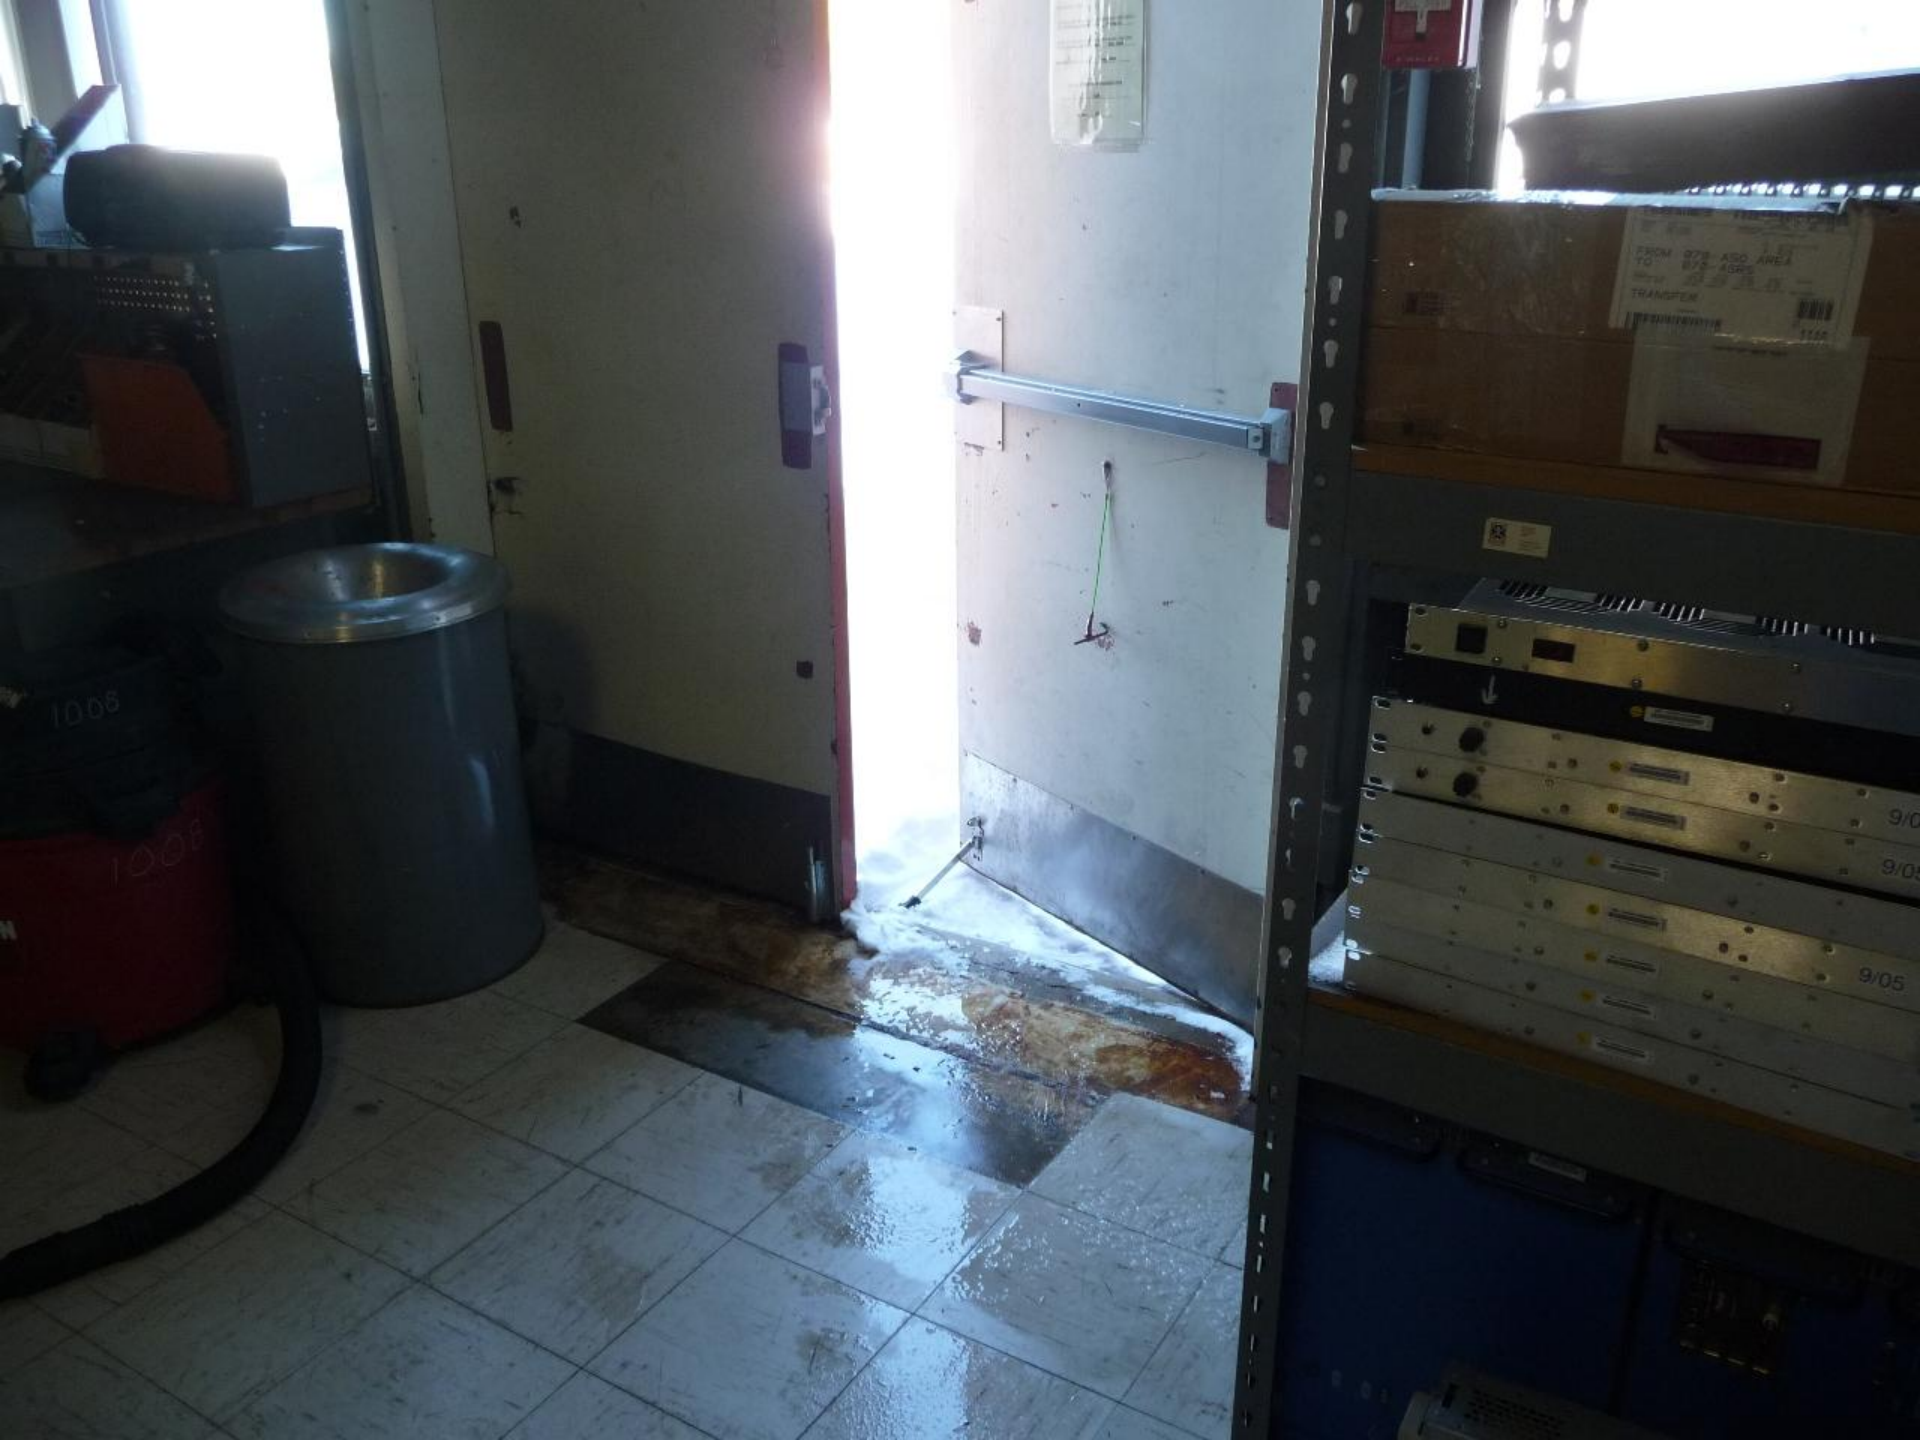
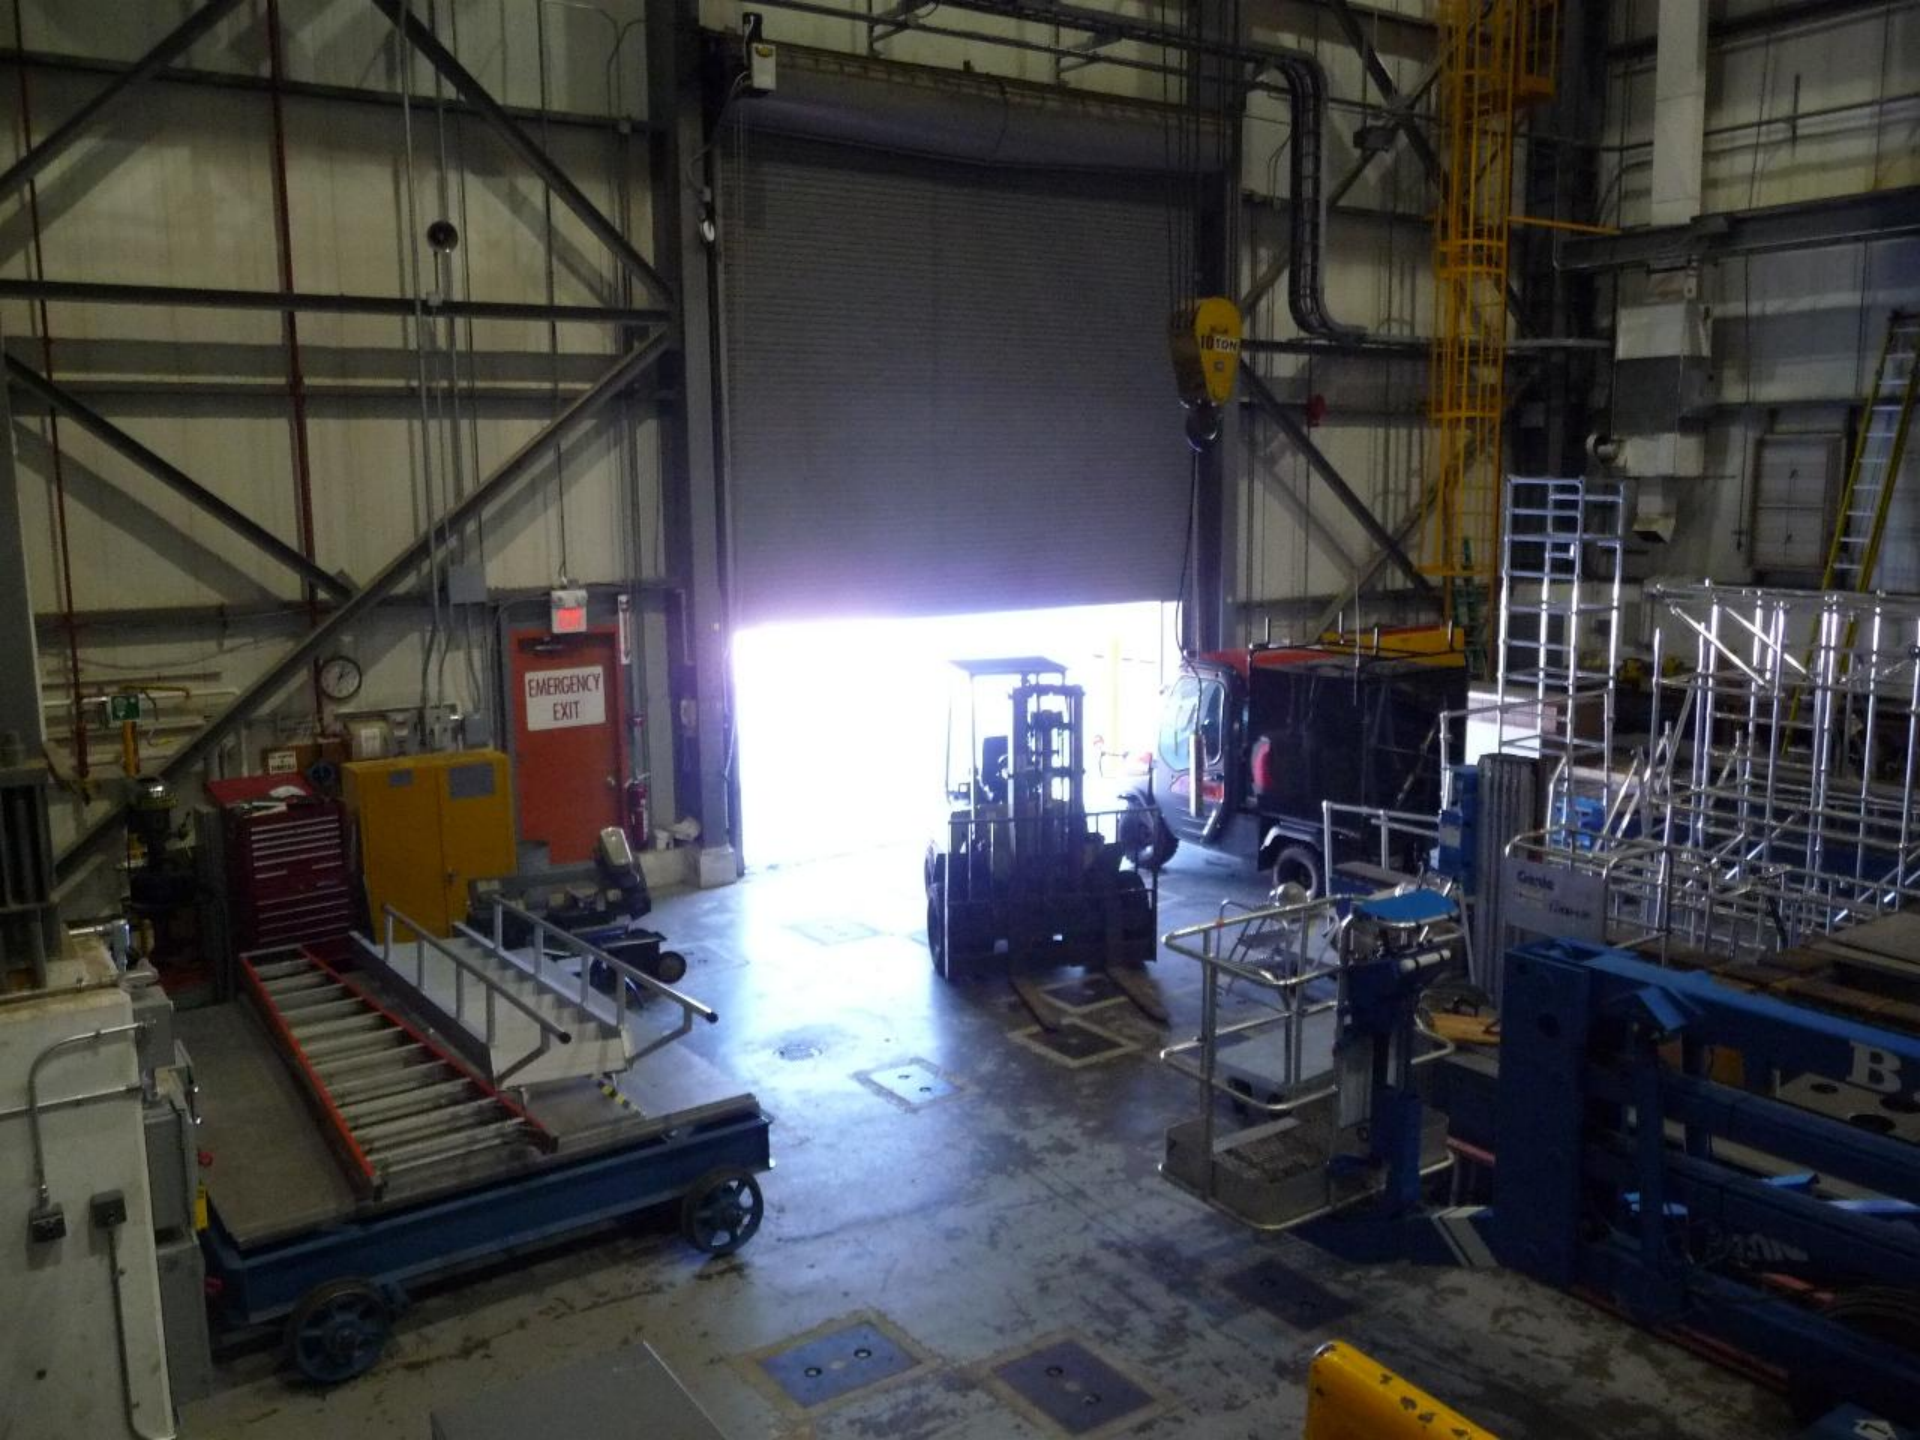
RACK ROOM AIR CONDITIONER AC-3 STATUS

- After many years of off-hour emergency calls to fix PHENIX Air Conditioner in Electronics Rack Room, finally new AC unit was installed in the 2009 shutdown
 - Installation took six weeks
 - Installation completed on November 24, 2009
- New unit consists of two compressors and three fans
- However
 - 2nd compressor and fans 2, 3 never came on!
 - 25-year-old air handling system was NOT replaced!

T-STAT
CALL

COMPRESSOR
#2

FAN
#2

FAN
#3

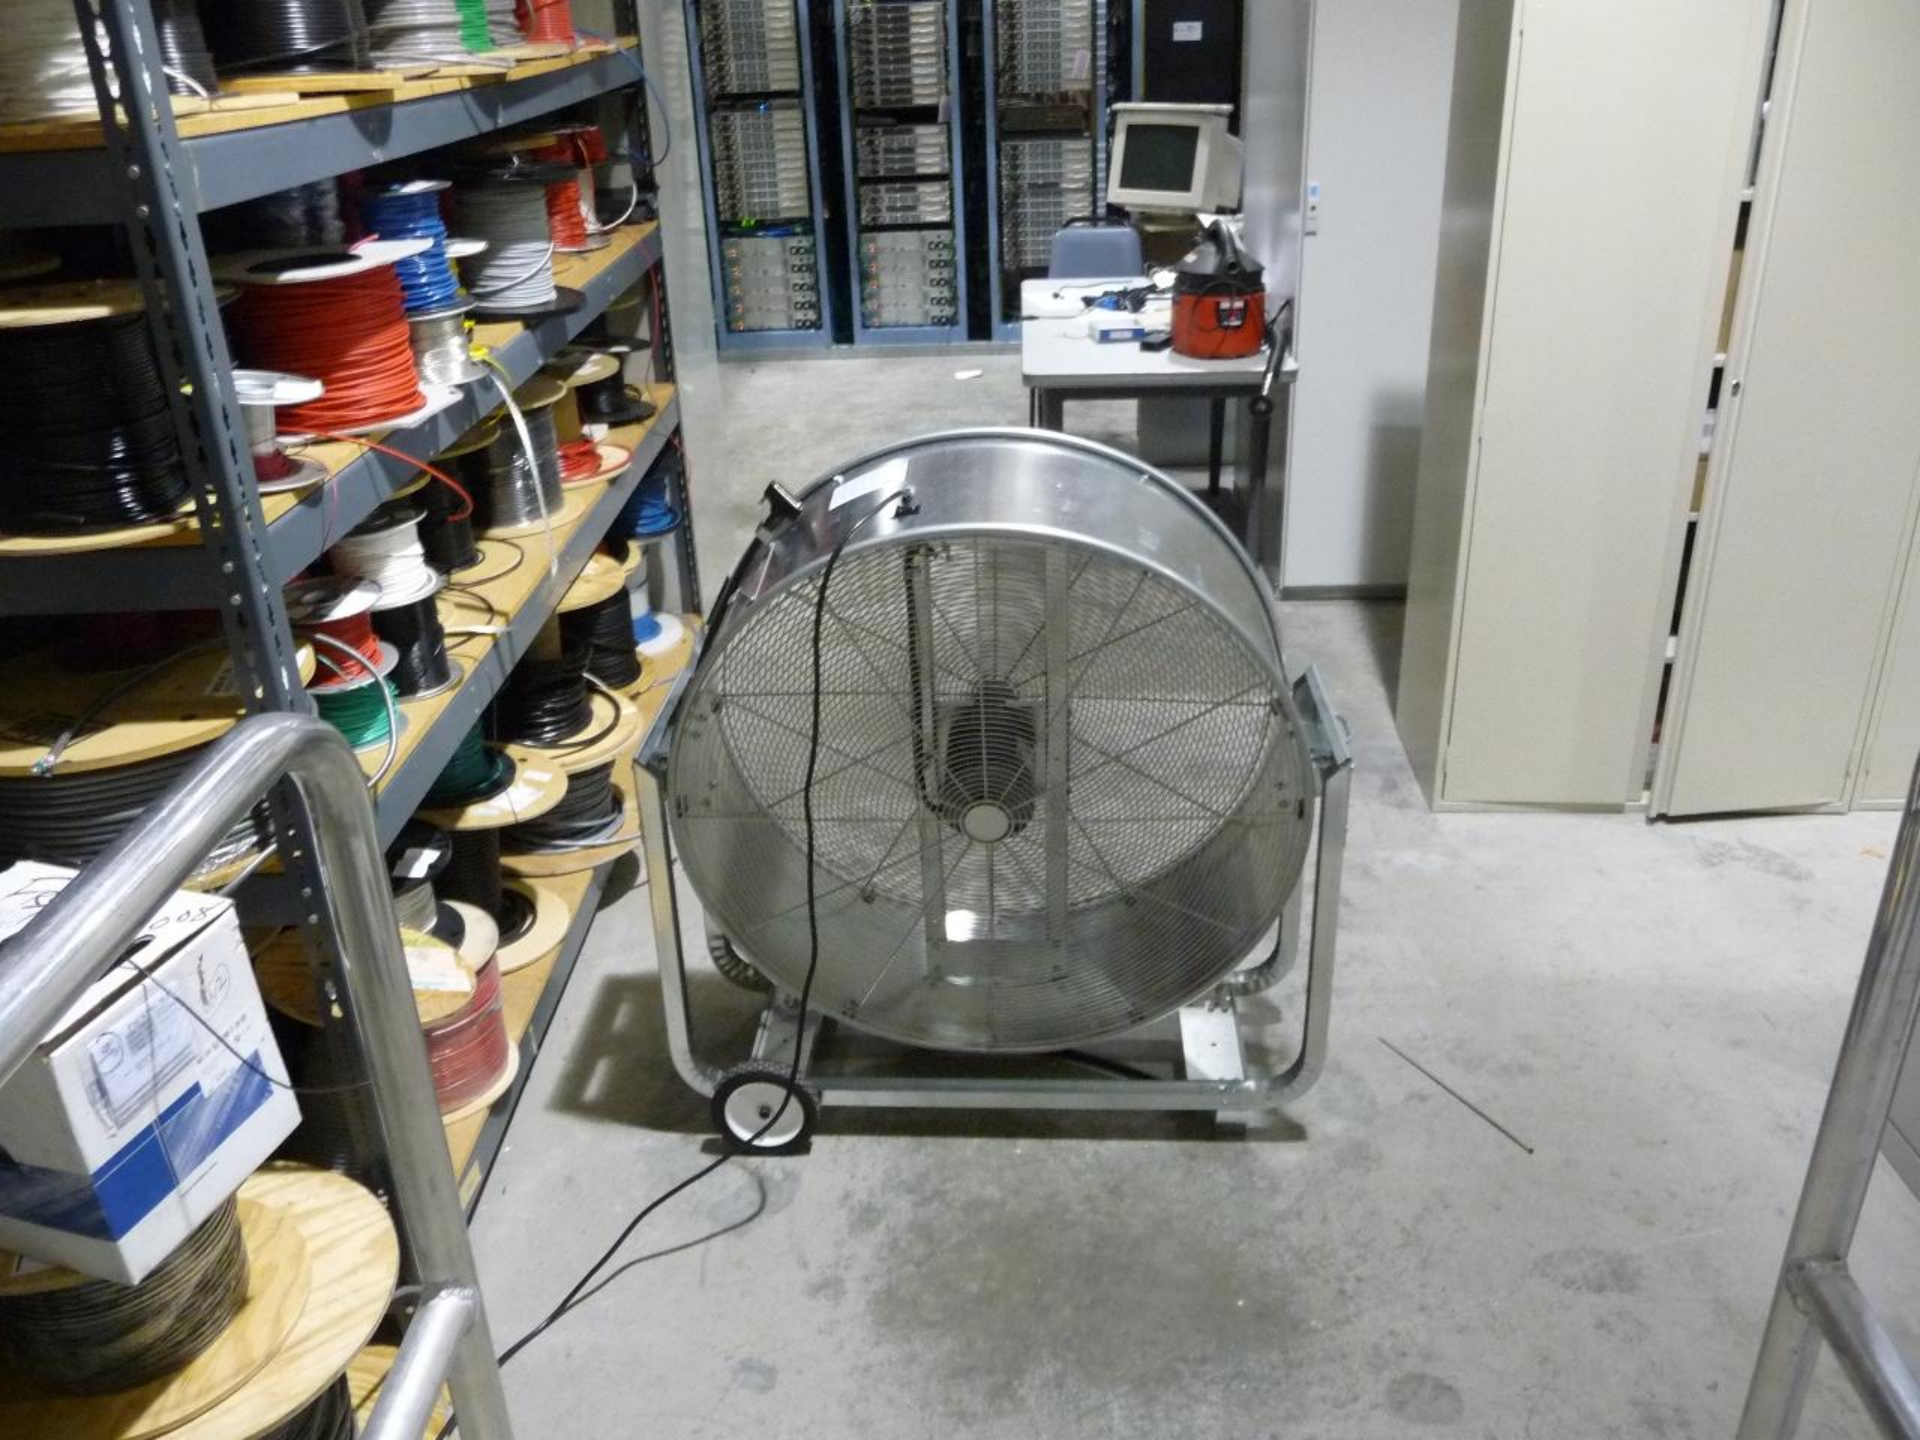
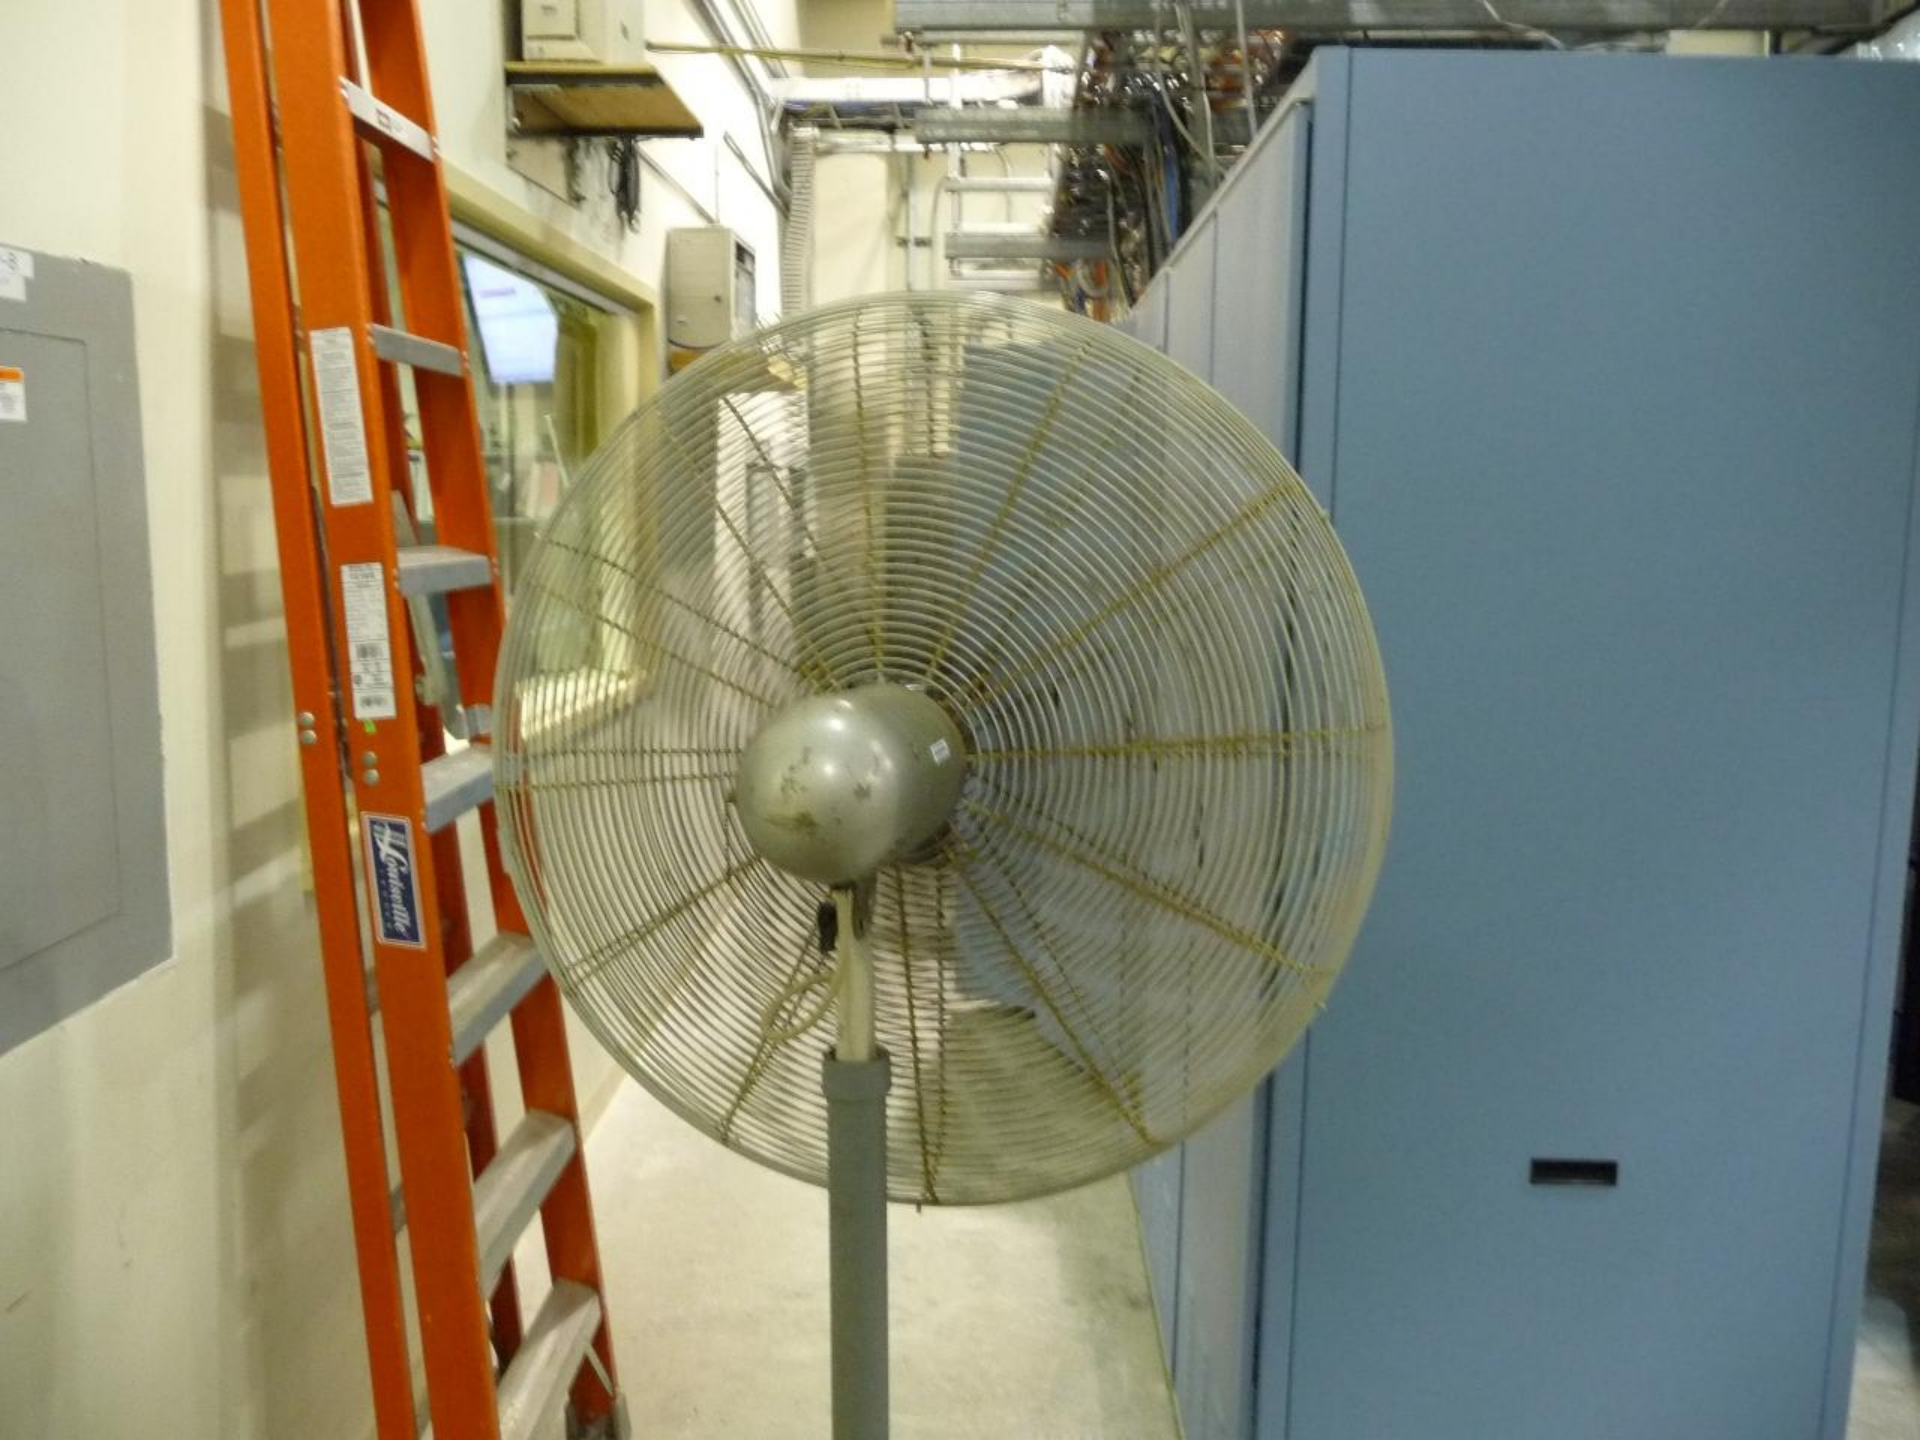
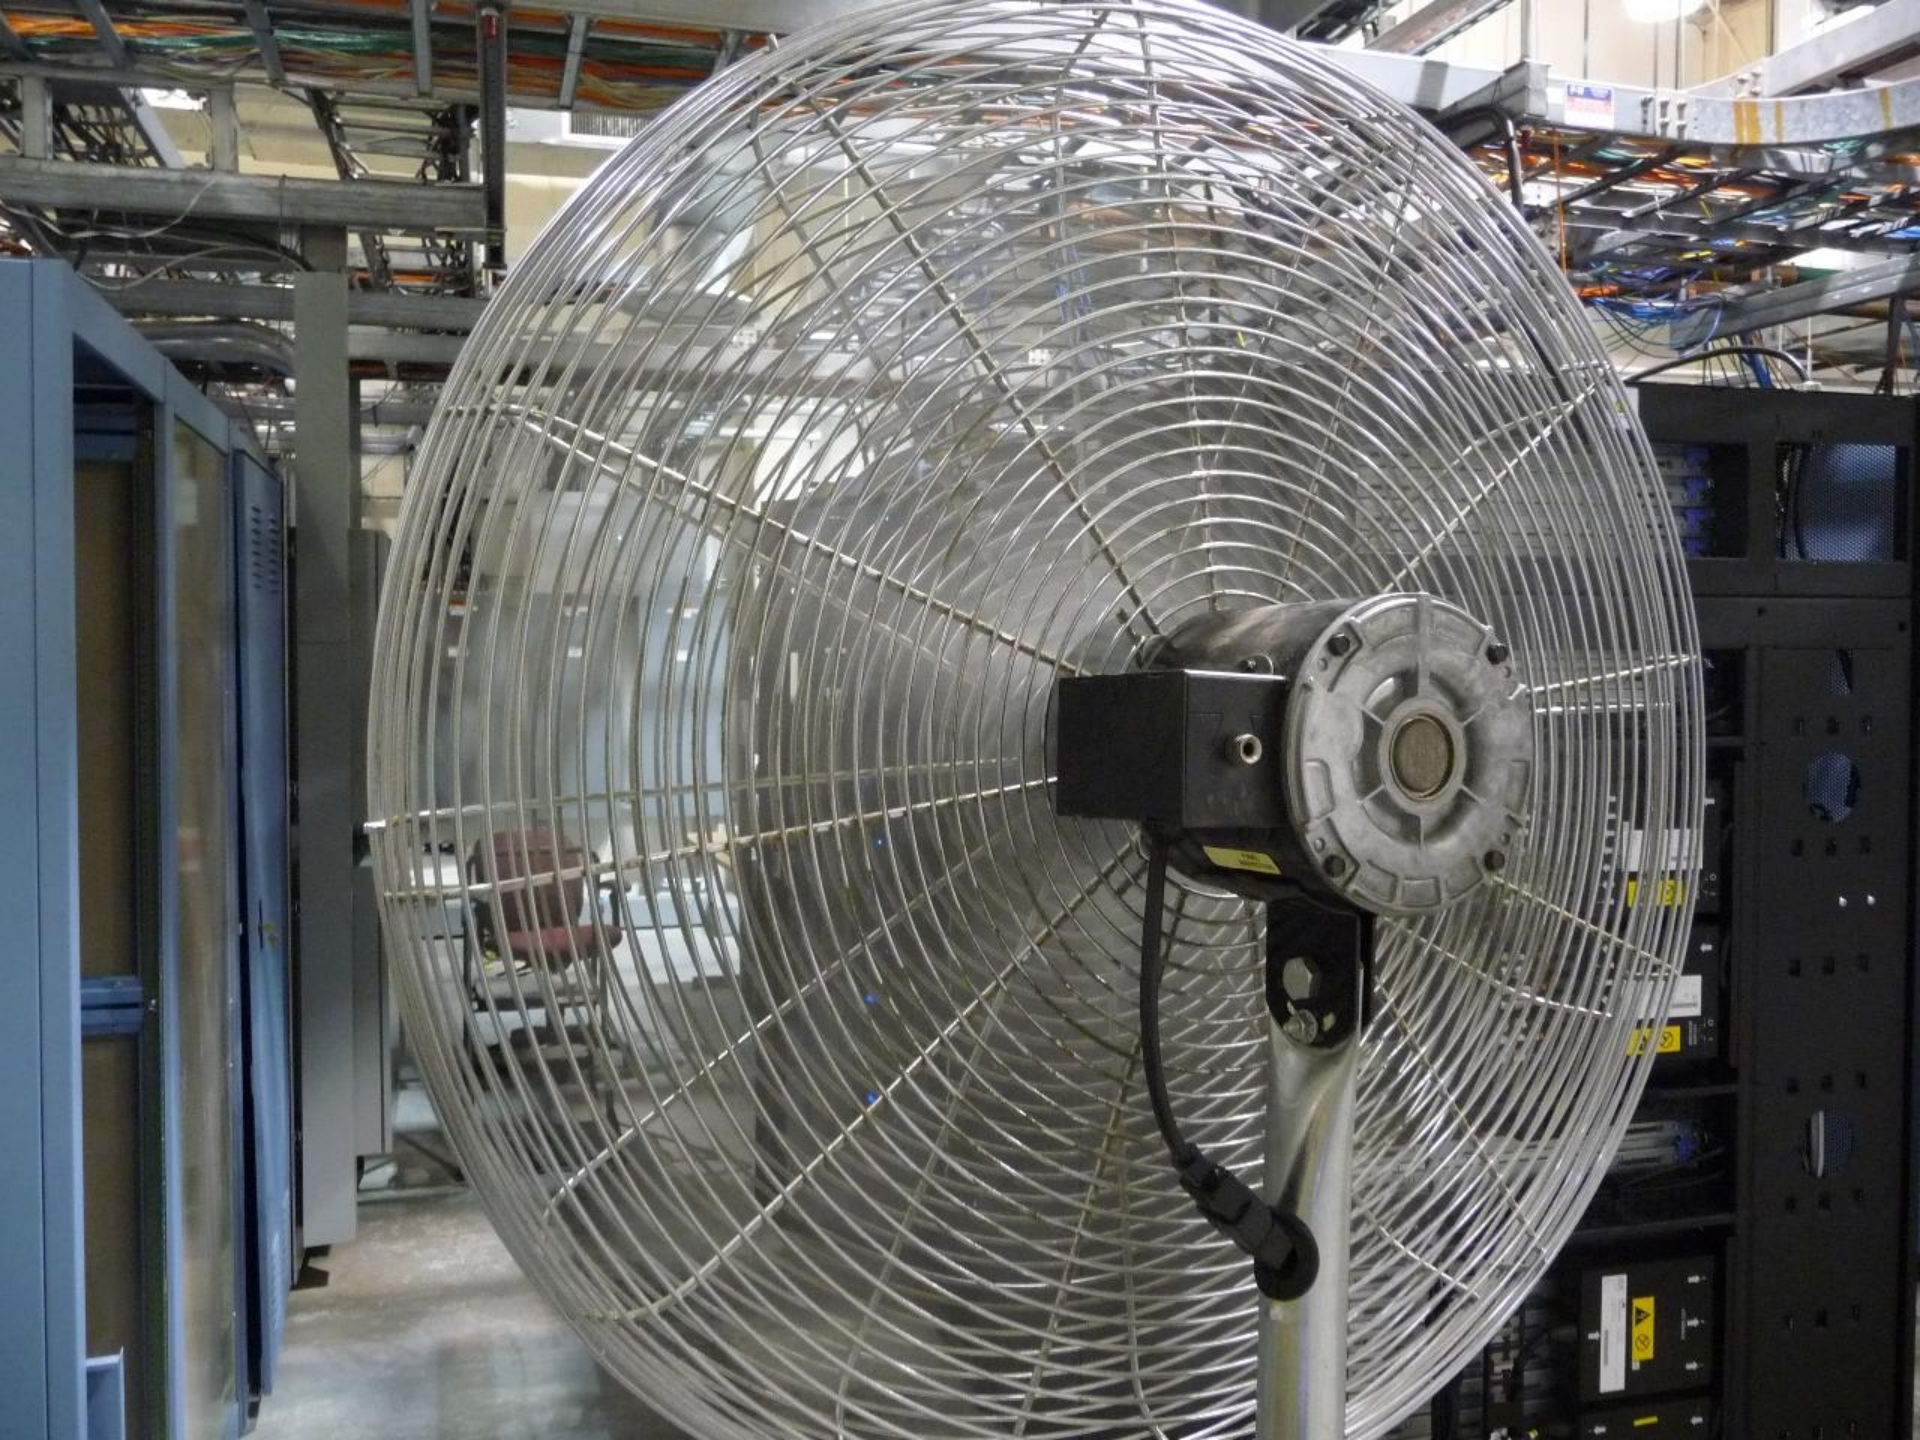
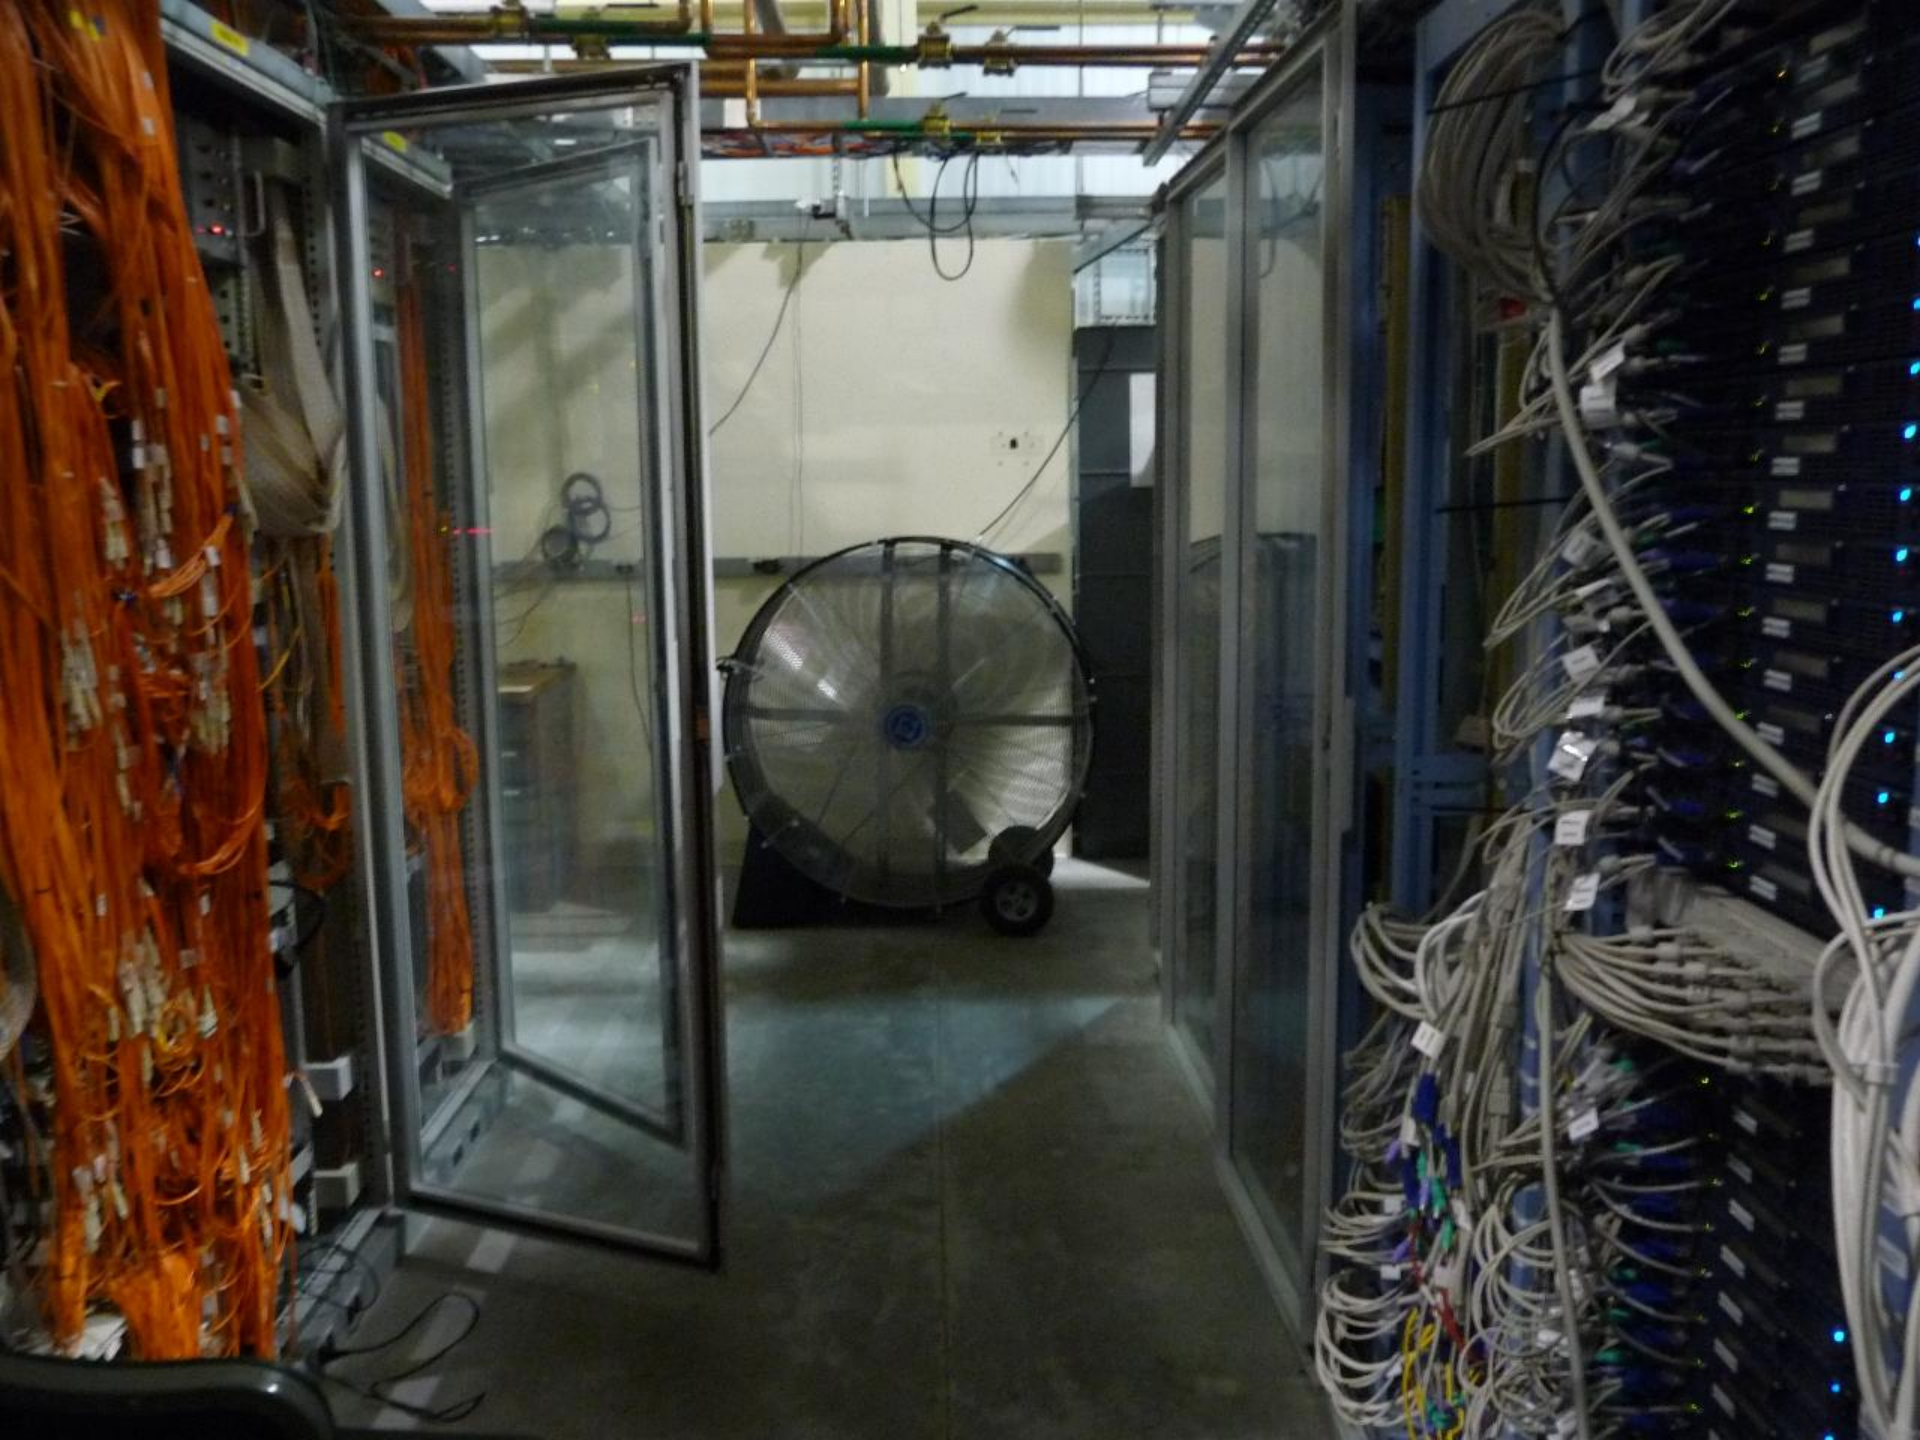
- On the past weekend it was discovered that AC was off and temperature in Rack Room was rising (already at 79 F)
- **Coincidentally?**, one of the six PHENIX buffer boxes for data taking failed
- Called MCR on Sunday, somebody came out, but said there was nothing he could do
- Opened outside door and turned mobile emergency fans on for relief
- Called MCR again on Monday, two guys came out
 - They were not able to switch the compressor back on
 - They manually opened the Economizer (outside air damper), which hadn't been opened in years
- **This means for years the AC was cooling even in the winter when the air was cold and a simple fan would have been sufficient**

- If
 - One out of two compressors and two out of three fans weren't activated at installation
 - The single operating compressor and the single operating fan fail only four weeks after installation
 - The 25-year-old air handler remains in place
 - The system is nothing but patched
- Then my prediction is we'll have many more emergencies to come this spring and summer

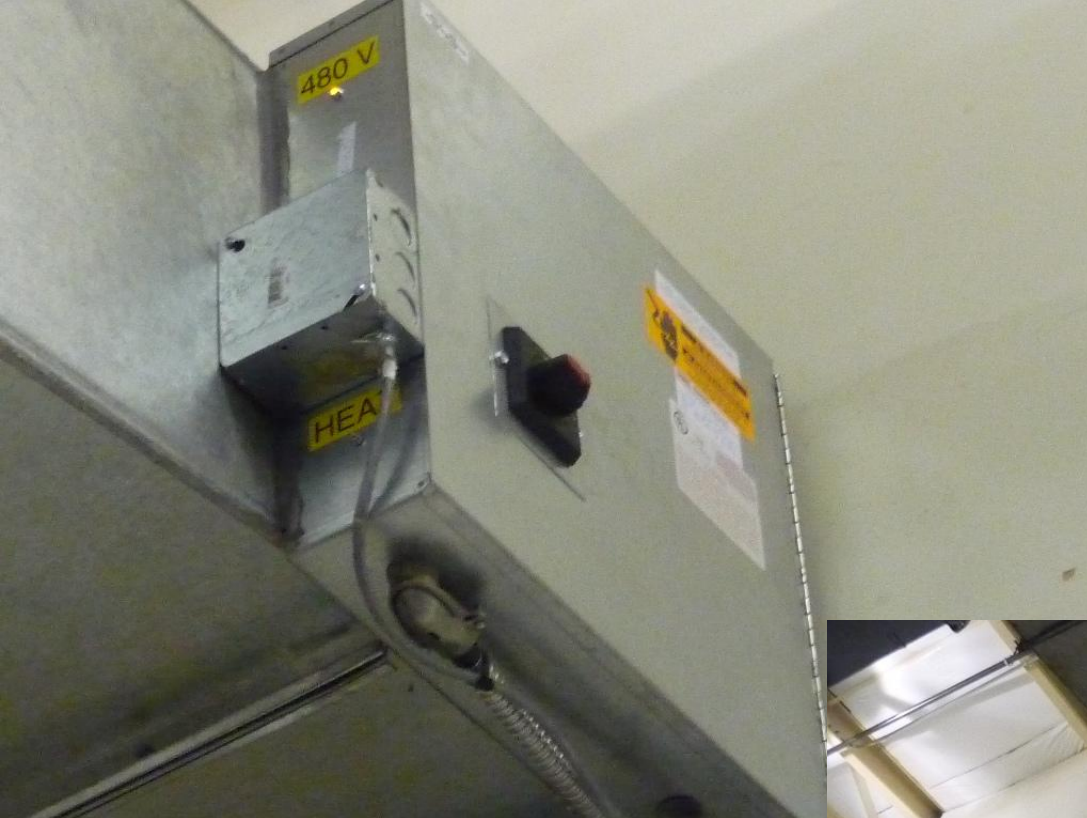
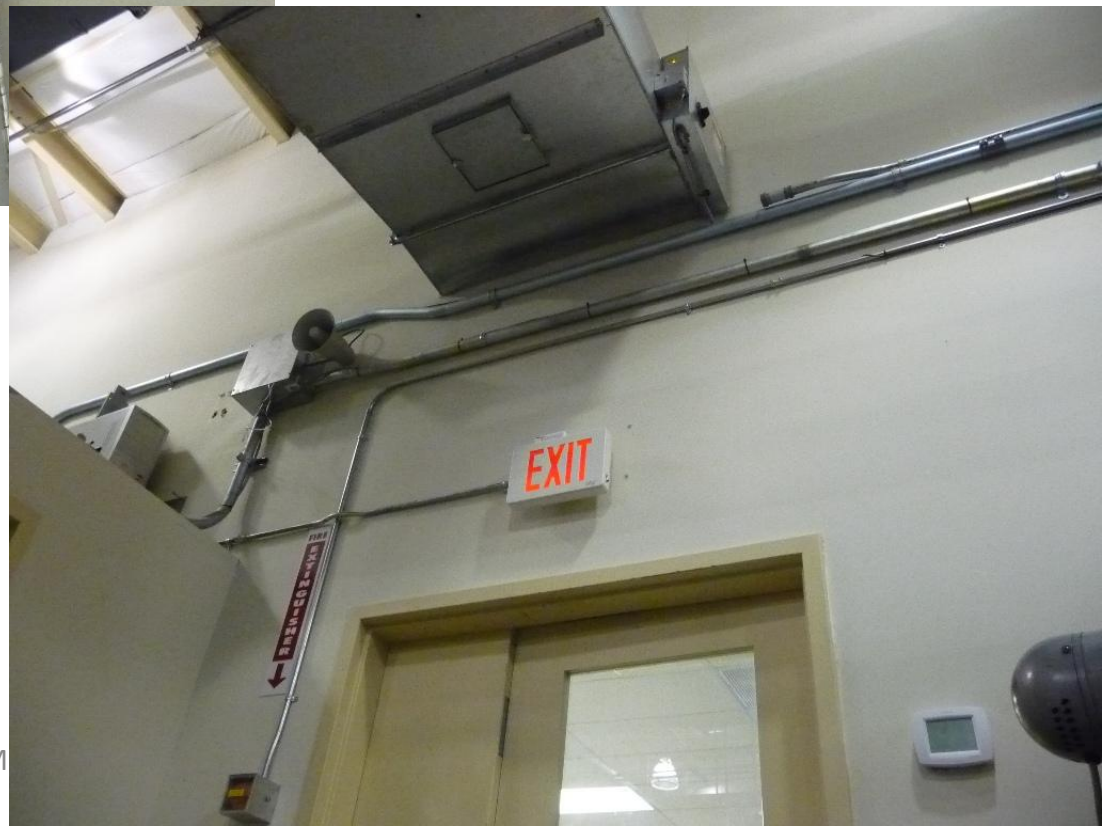
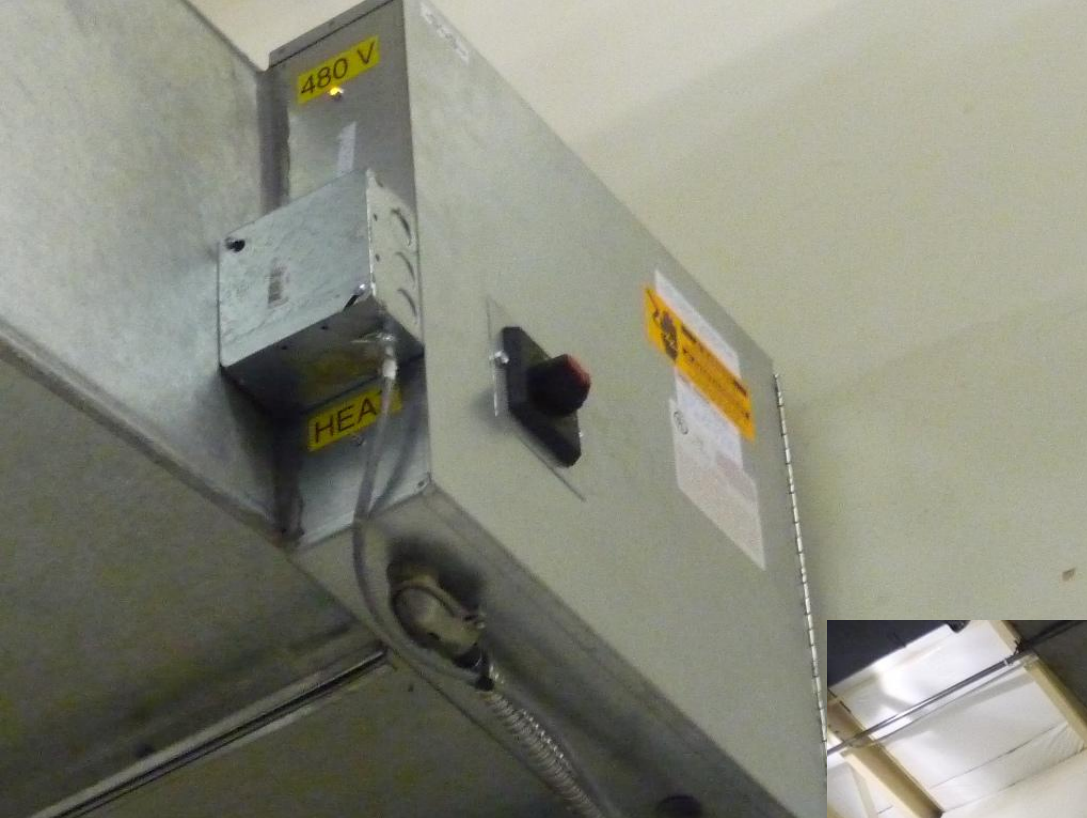
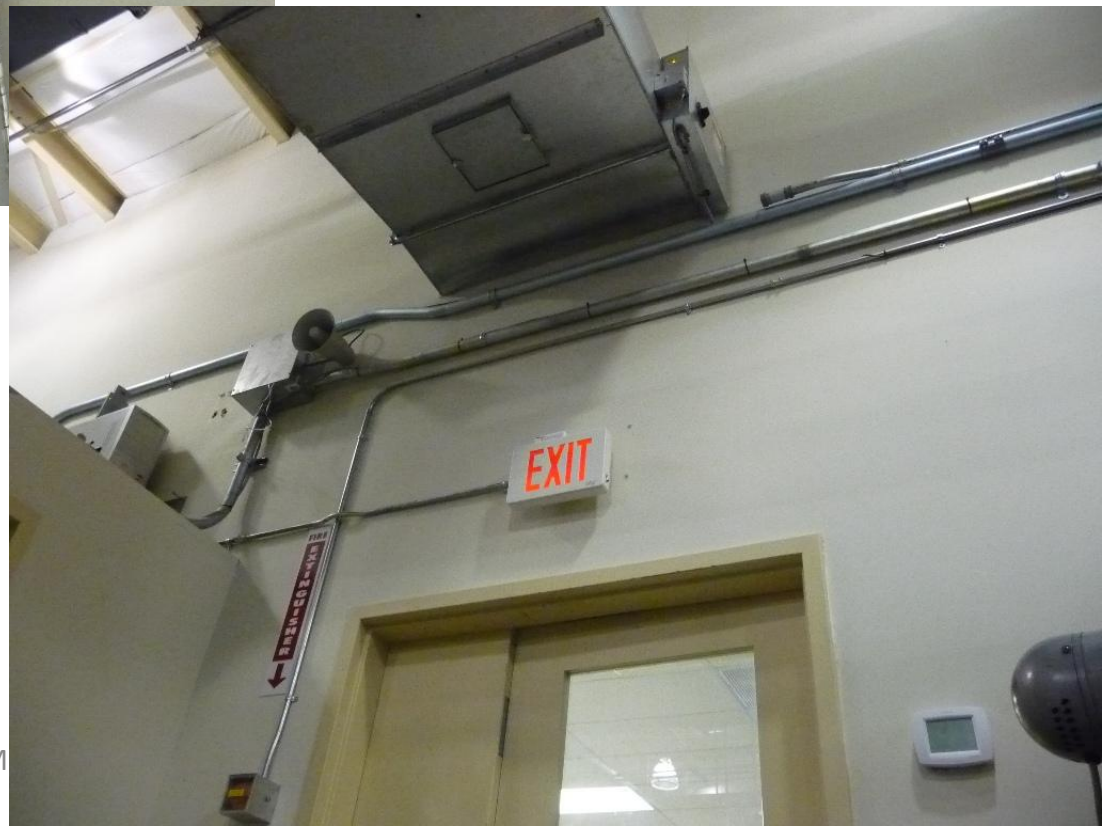
- AC compressor also runs on cold winter days wasting energy (as mentioned above)
- In addition, the (to be cold) Rack Room and the (to be warm) Control Room are served by the same AC
- “Solution”: 30 kW heater to heat up the previously cooled down air
- This has been in place for the past 10 years and was not changed when the new AC unit was installed in the 2009 shut down
