# The RHIC Beam Abort Kicker Instability Issues

A. Zhang, J. Mi, and J. Sandberg  
Collider-Accelerator Department

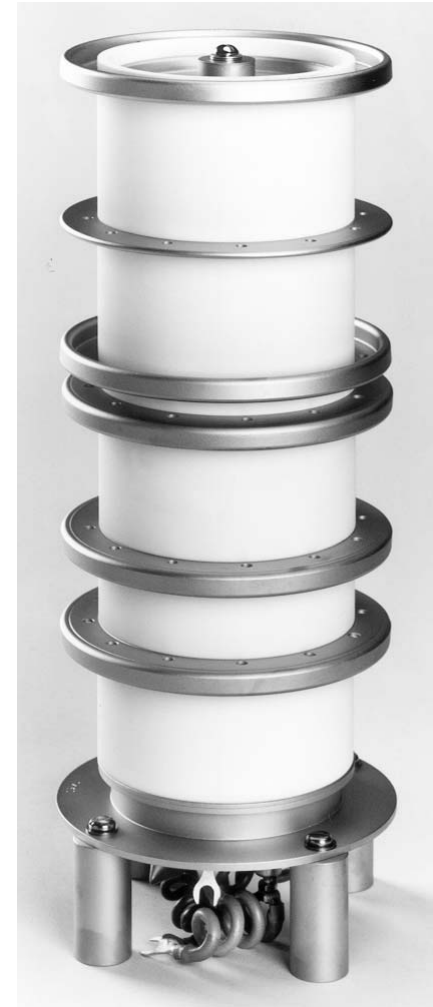
# THYRATRON e2v

## CX3575C

Adjustable Reservoir, Filament & DC Prime Grid  
Control Grid

| Peak forward anode voltage . . . . . | 60 kVmax |
| Peak forward anode current: | |
| modulator service . . . . . | 10 kAmax |
| crowbar service . . . . . | 50 kAmax |
| Peak reverse anode current: | |
| modulator service . . . . . | 5 kAmax |
| crowbar service . . . . . | 25 kAmax |
| Average anode current . . . . . | 3.0 Amax |
| Rate of rise of current . . . . . | 100 kA/us |
